THPA
CONTAINER PORT STS
OVERHAUL
STTC-V0

CONTAINER PORT Ship To Shore (STS) OVERHAUL

Specific Technical Terms and Conditions

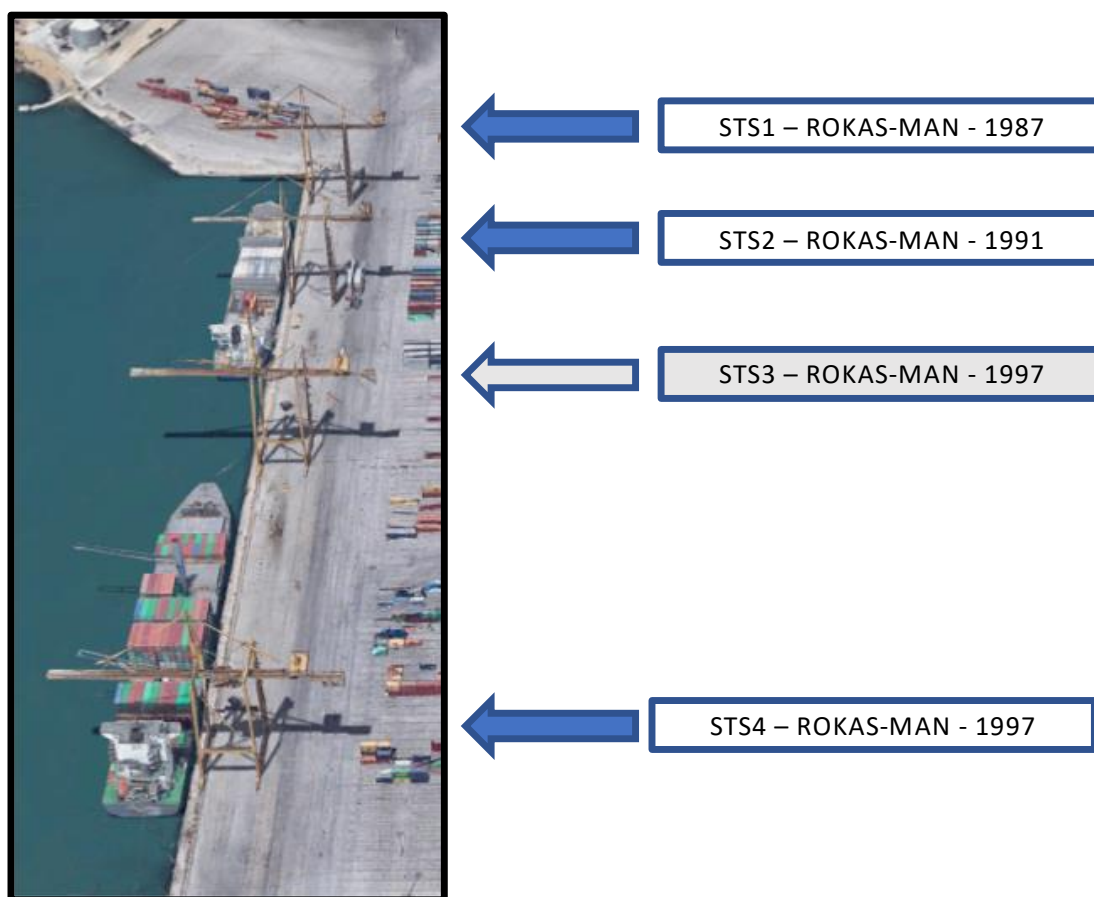
THPA operates the container terminal of Thessaloniki. The terminal is equipped with 4 STS (Ship To Shore) container gantry cranes numbered STS 1 to STS 4

Figure 1 - Container terminal STS
